A Unique Task

Sep 30, 2025 | 43 Photos

# Commercial Example Report

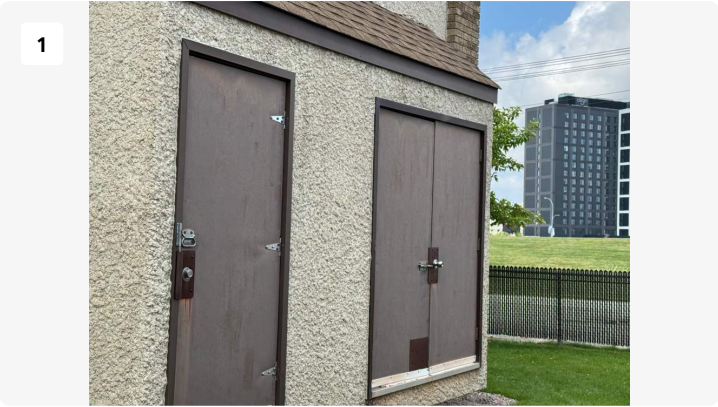
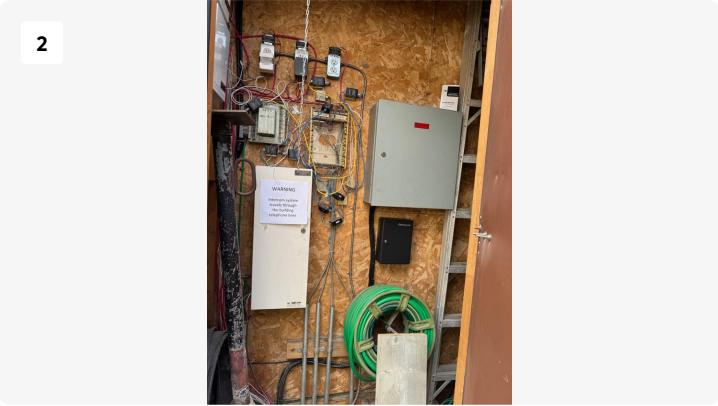
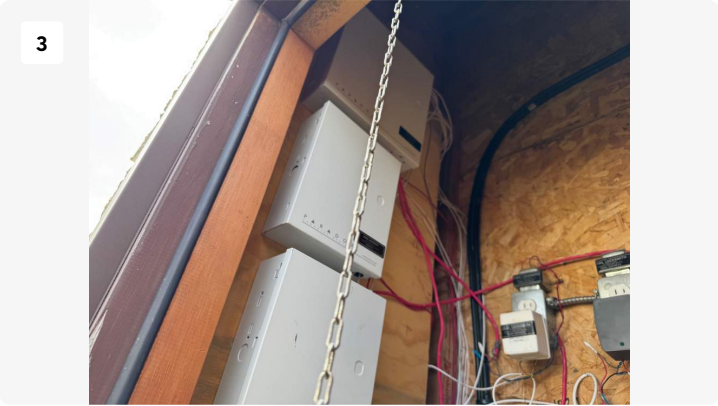
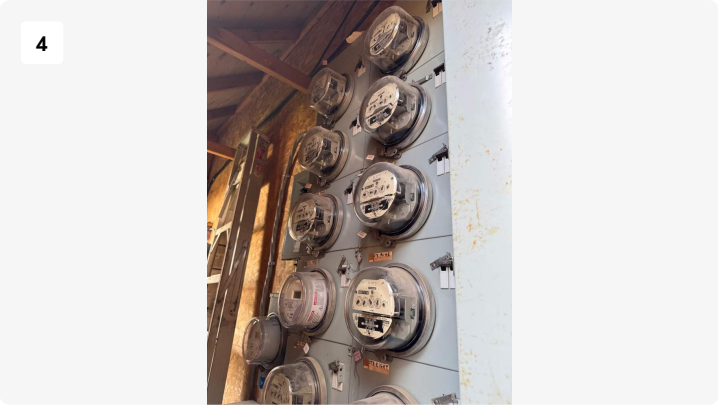
- Equipment appears secure, weather-protected, and free of corrosion or water damage.
- Wiring and conduit are generally in order, but communication panel is cluttered.
- No evidence of pests or structural damage.

- Loose/unsupported wires in communication panel.
- Open floor-level conduit penetrations (pest entry risk).
- Stored ladder, hose, and materials obstruct safe access.
- Locking hardware may not meet tamper-resistant standards.

- Engage licensed electrician for wiring organization and code compliance check.
- Seal floor-level conduit penetrations.
- Remove storage items to maintain clear service access.
- Upgrade locks for improved utility security.
- Maintain routine electrician inspections and update labeling for emergency clarity.

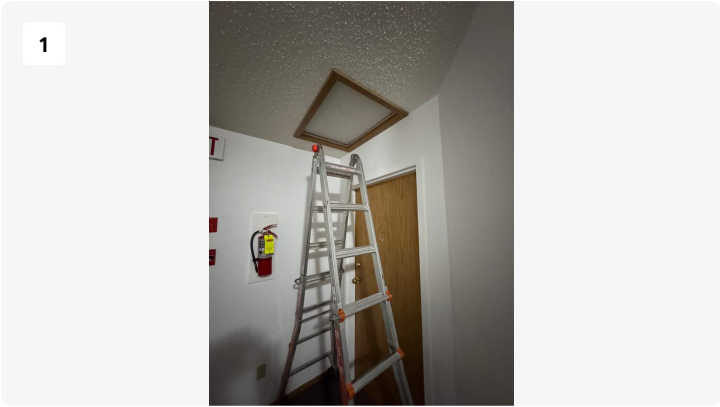
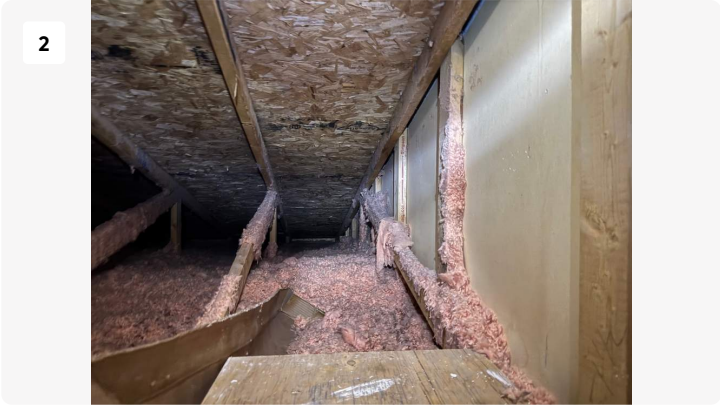
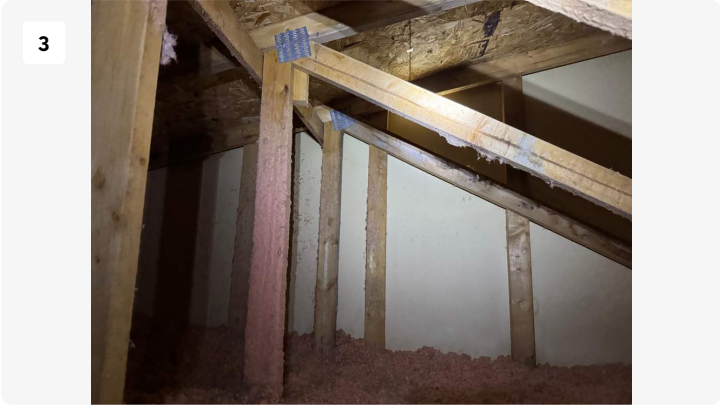
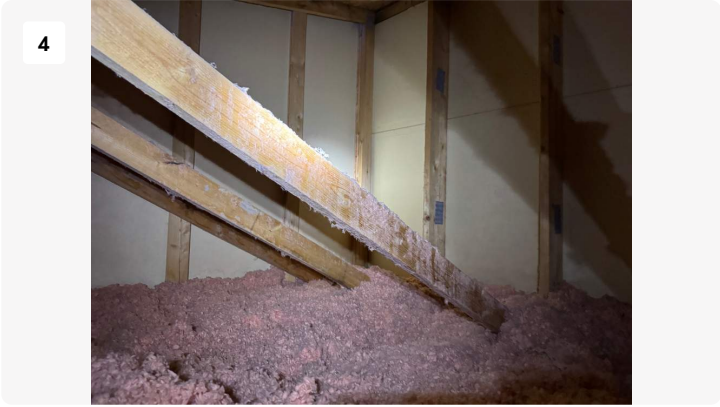
- Attic accessed via hallway hatch and through storage rooms of Units 9–12.
- Insulation and structural framing in generally acceptable condition.
- No water intrusion or ventilation issues noted.

Hallway hatch and unit storage room hatches are unsecured.

Allows unregulated entry into a shared attic space → security & liability concern.

Drywall seams unfinished, gaps around penetrations.

No fire-blocking/draft-stopping.

Fire-rated drywall upgrades missing → compromised life safety compliance.

- Access Control: Lock or restrict all attic hatches; limit to management/authorized personnel.
- Fire Safety: Tape/mud seams, add second Type X drywall where required, seal penetrations with fire-rated materials.
- Compliance: Engage licensed fire protection consultant/code specialist to confirm Manitoba Building Code requirements.

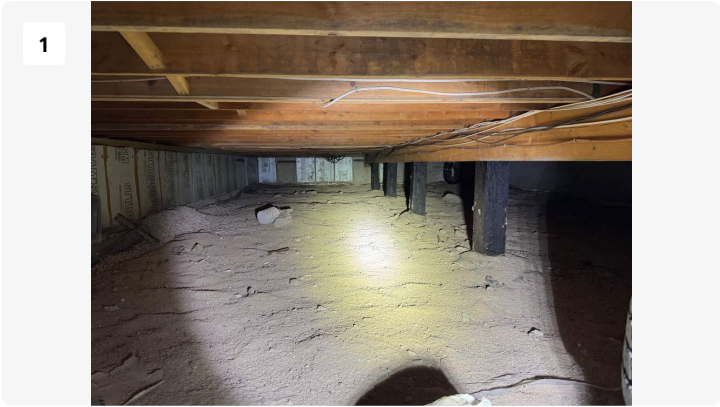
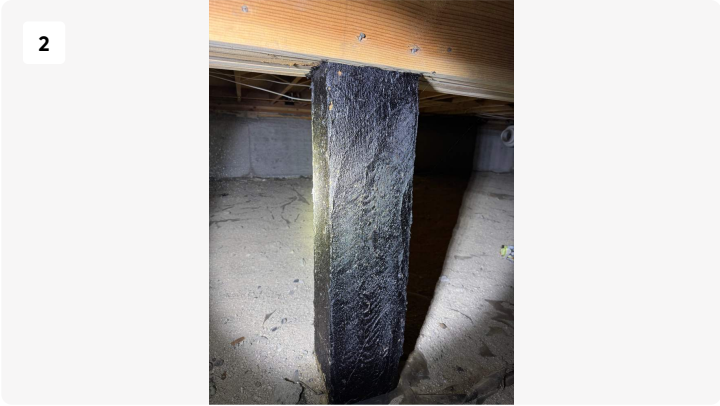
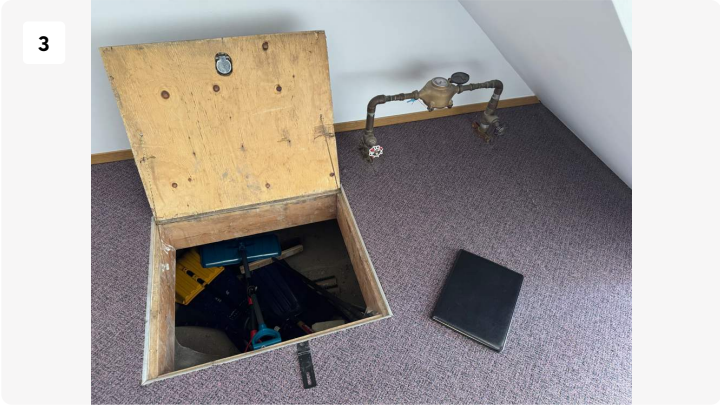
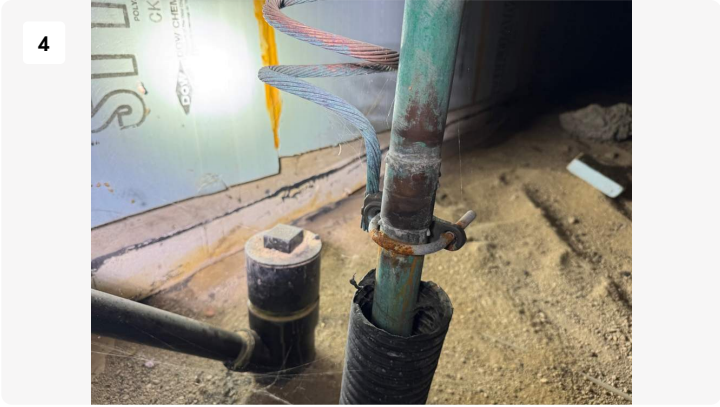
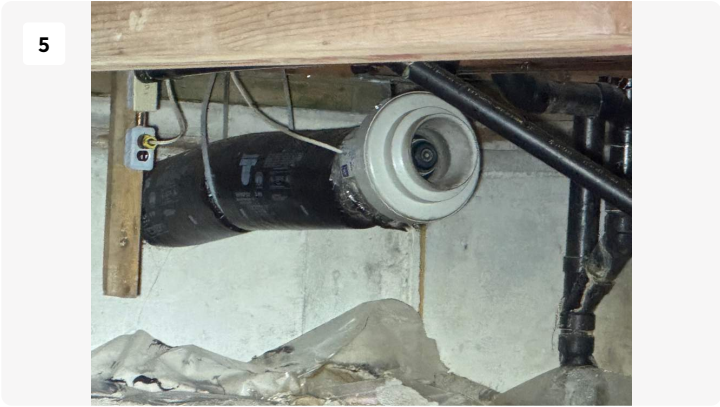
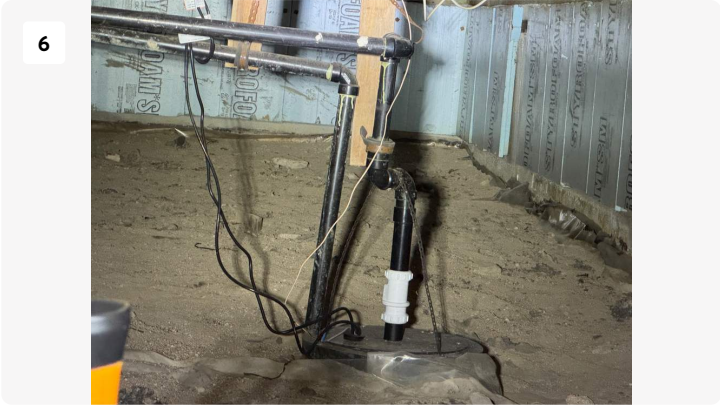
- Entry via hatch in finished floor.
- Issue: Vertical drop with no ladder → unsafe for inspections/maintenance.

- Floor framing sound; no visible deflection.
- Posts coated with tar-based sealant (standard moisture protection).
- Concrete foundation intact, no cracks or seepage.

- Crawl space dry at time of inspection.
- Poly vapor barrier present but incomplete and not sealed at seams.
- Ventilation appears adequate.
- Operational sump pump supports moisture control.

- Stelpro heater functional.
- Smoke detector installed overhead.
- Issue: Some loose electrical wiring requires fastening.

- Access Safety: Install fixed ladder/steps for safe entry.
- Electrical Safety: Secure loose wiring per code; have electrician verify installations.
- Moisture Protection: Extend/seal vapor barrier across entire floor and seams.
- Life Safety: Test/maintain smoke detector; confirm compliance with code.
