A Unique Task

General Information

BUILDING ADDRESS: 987 Walkthrough Drive

INSPECTION DESCRIPTION: Walk through inspection

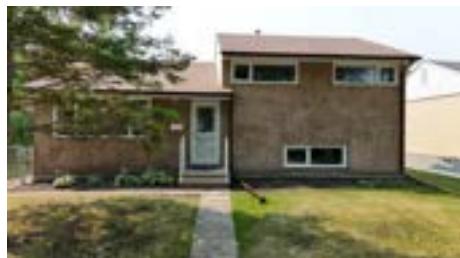
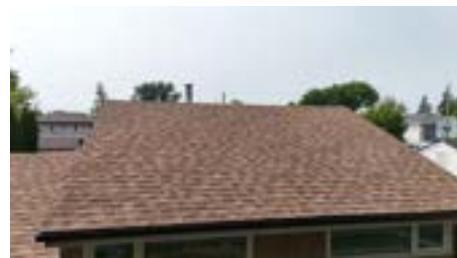
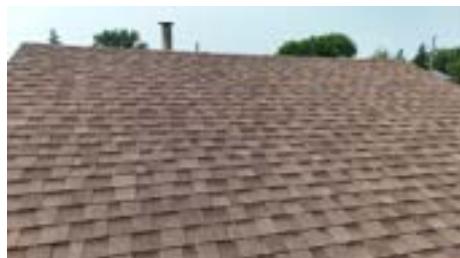
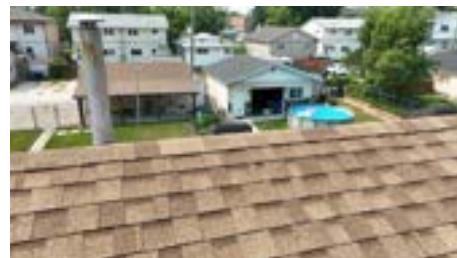
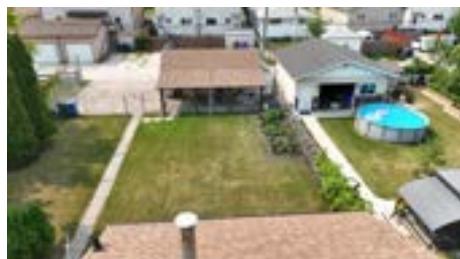
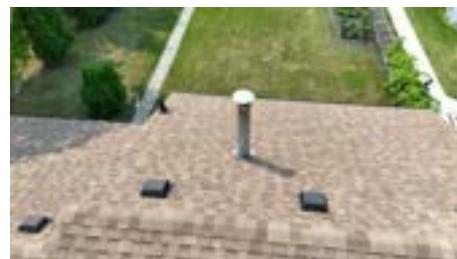
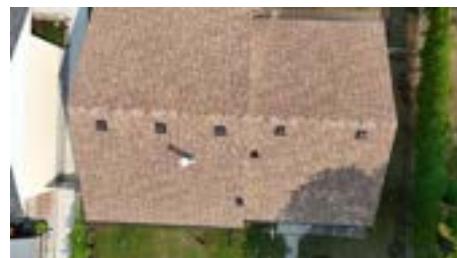
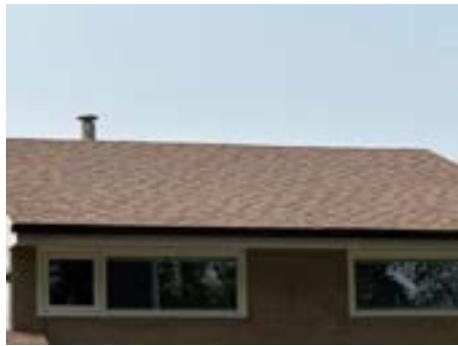
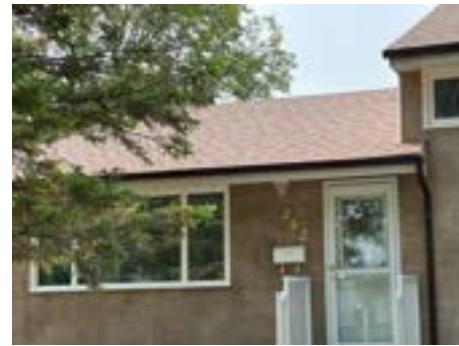
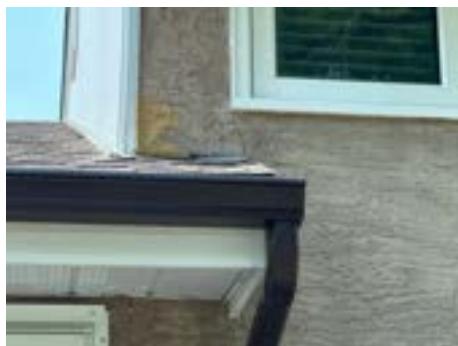
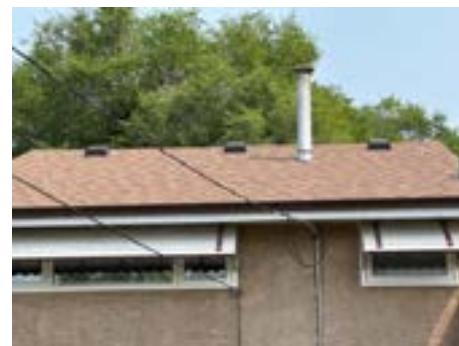
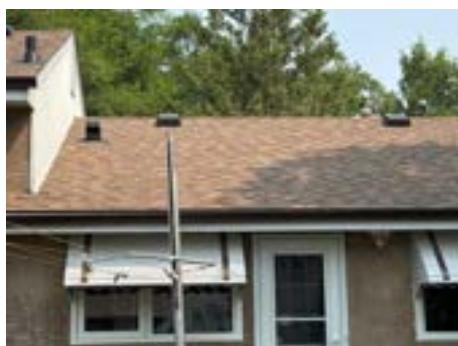
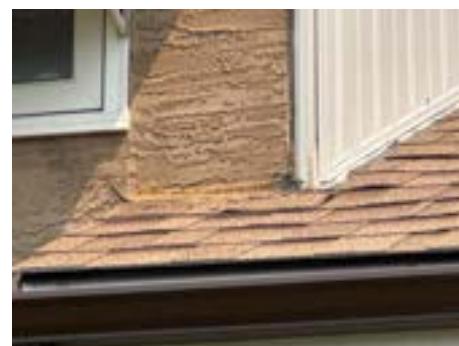
ROOF

39 inch two-tone brown architectural style fibreglass shingle appears to be in good repair. No recent signs or repairs no visible wind damage. No signs of impact appears to be in great condition. Should last another 20+ years if well-maintained. This is not necessarily cause for alarm, but something any homeowner should be aware of. Continue to monitor, if condition deteriorates contact a qualified contractor. Minor sealed areas will need yearly inspection and preventative maintenance

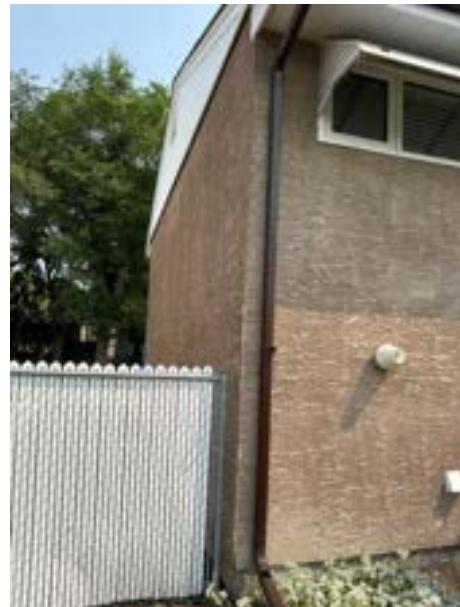
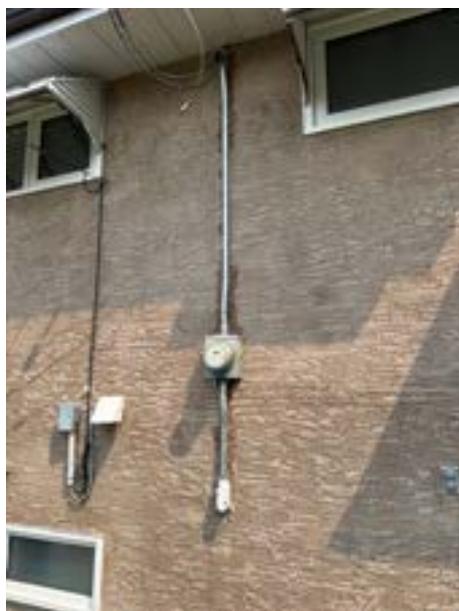
LANDSCAPE GRADING Poor

Grading should be increased to allow water to flow away from foundation.

Conclusion: Proper grading is a critical defense against damage, moisture intrusion, and costly repairs. It is recommended that homeowners periodically inspect grading conditions and make adjustments as needed to maintain positive drainage away from the home.

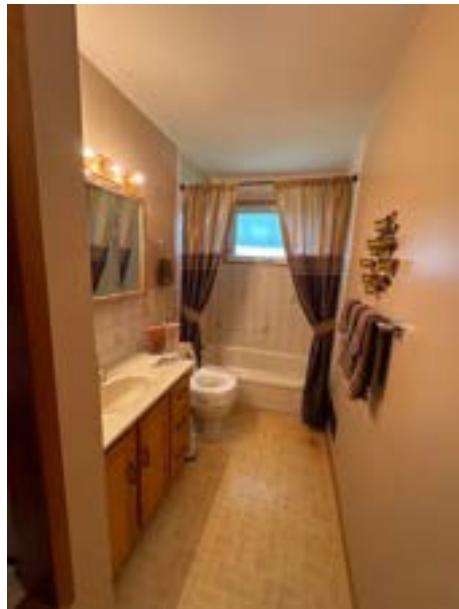
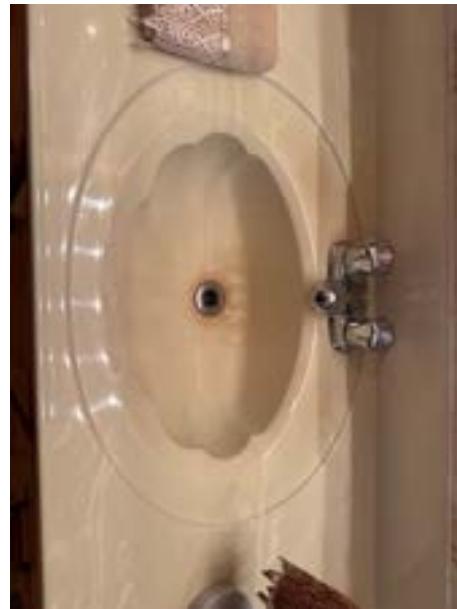
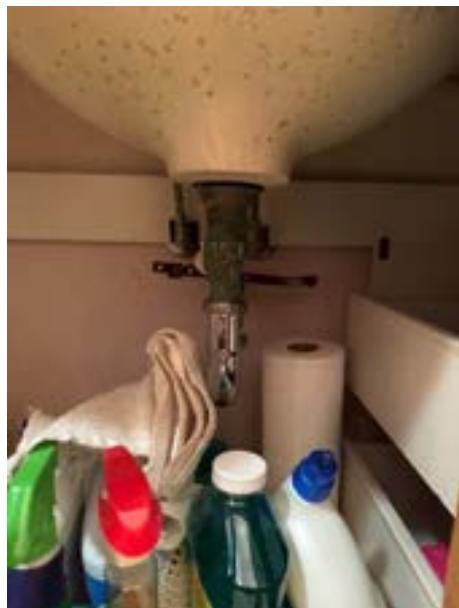
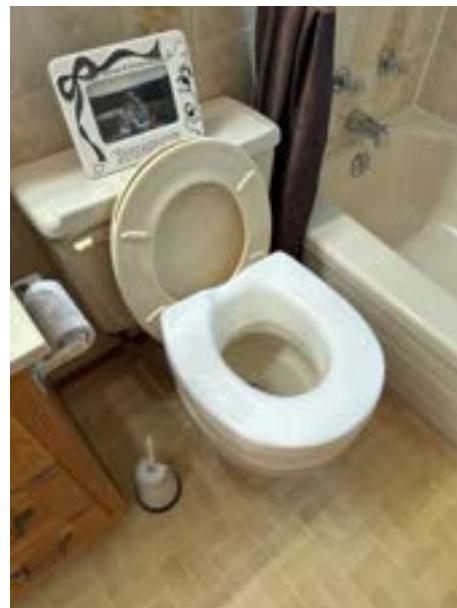
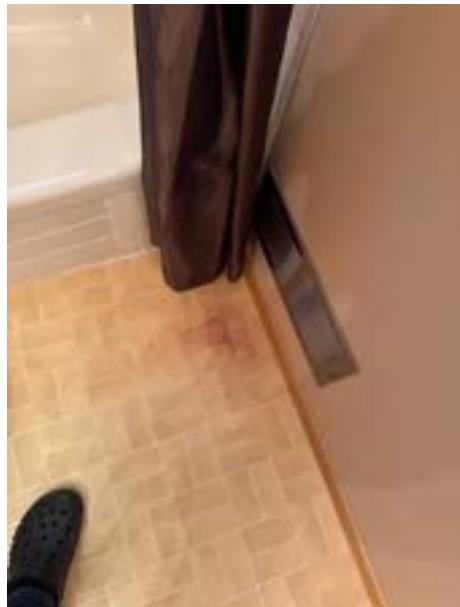
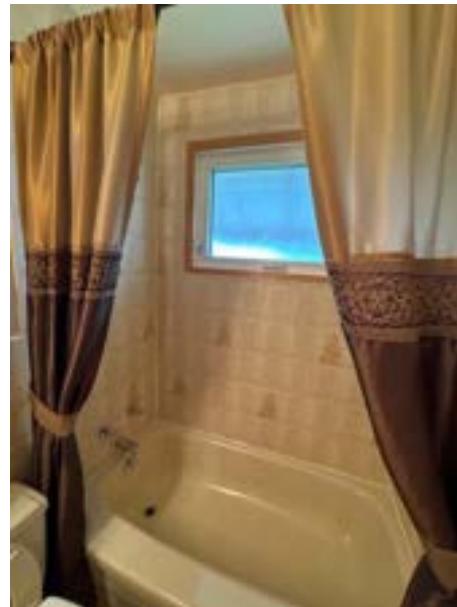
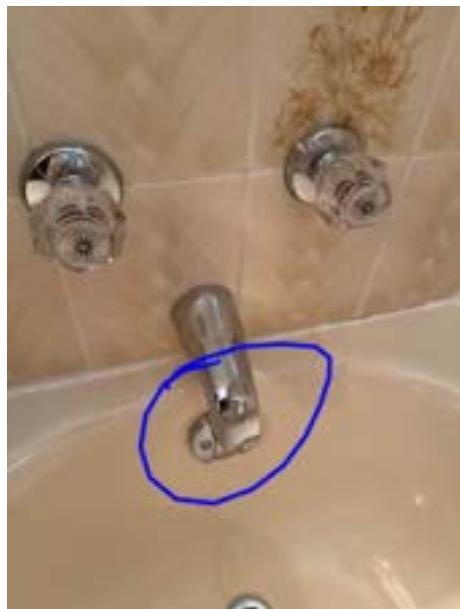
BATHROOM 1

Tap on tub seized Needs maintenance and repairs.

Old staining now meters dry

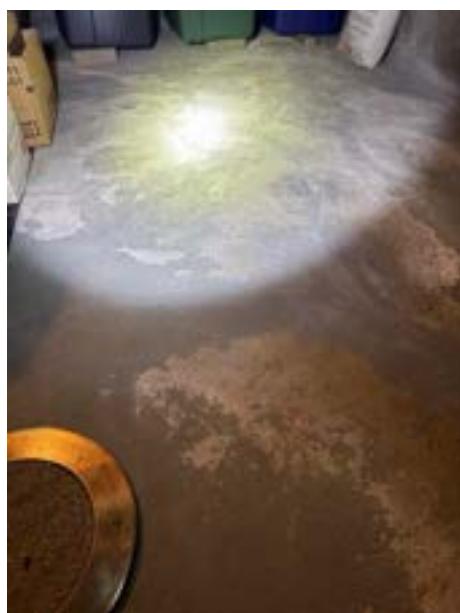
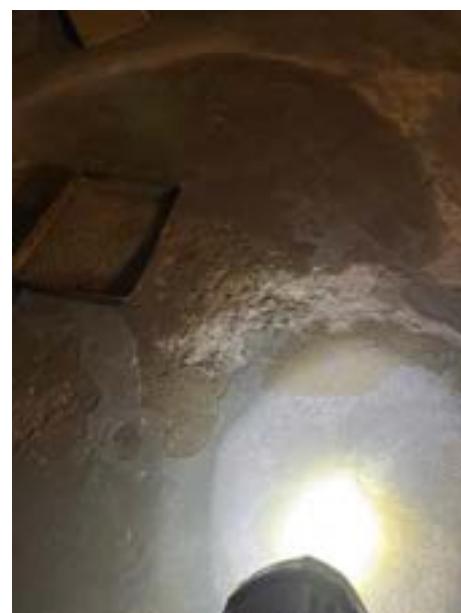
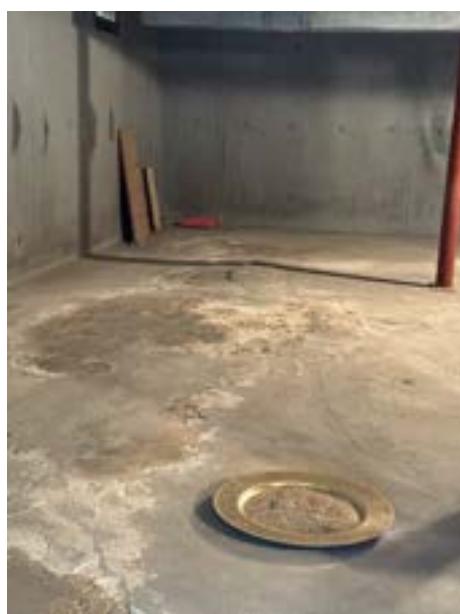
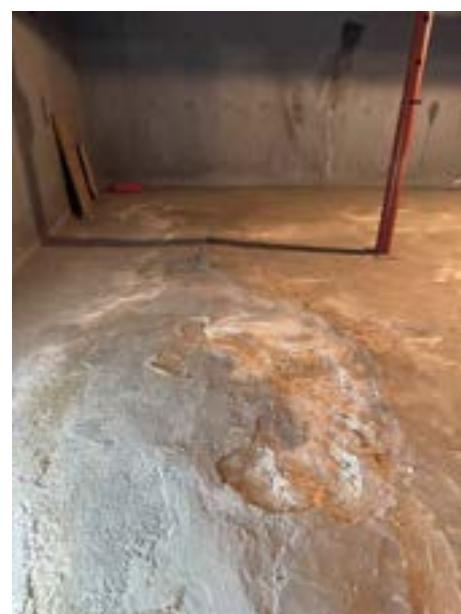
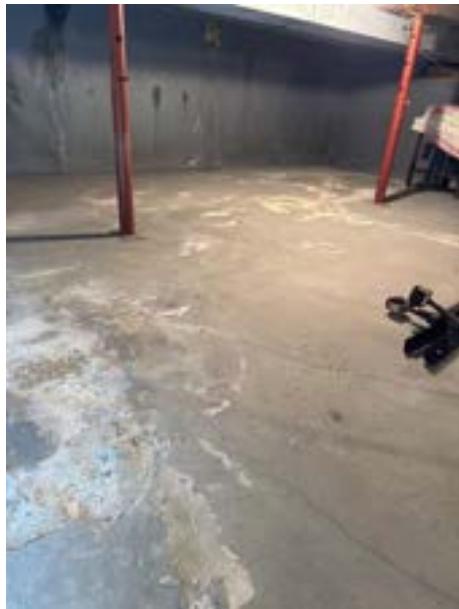
SLAB N/A

No heaving just uneven pour of concrete. Due to lack of ventilation and poor workmanship concrete and paint peeling.

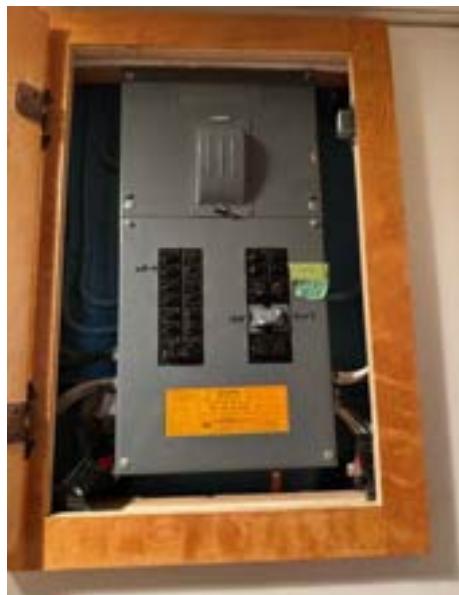
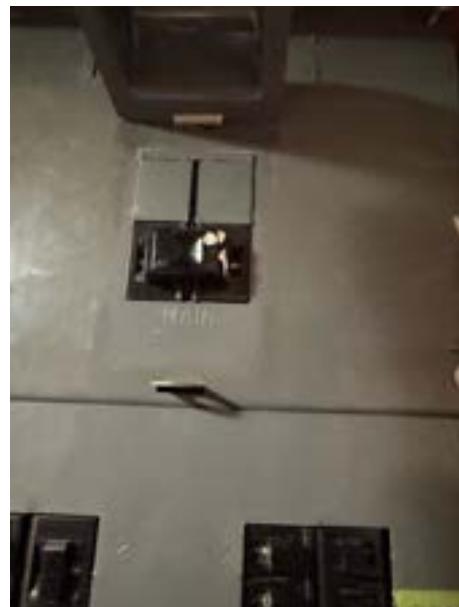
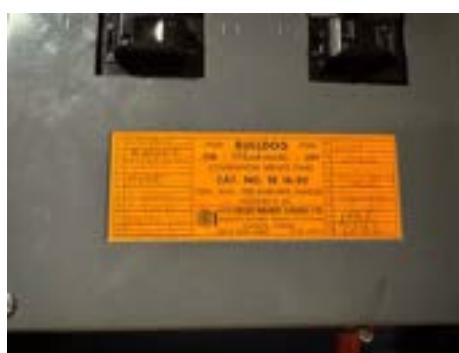
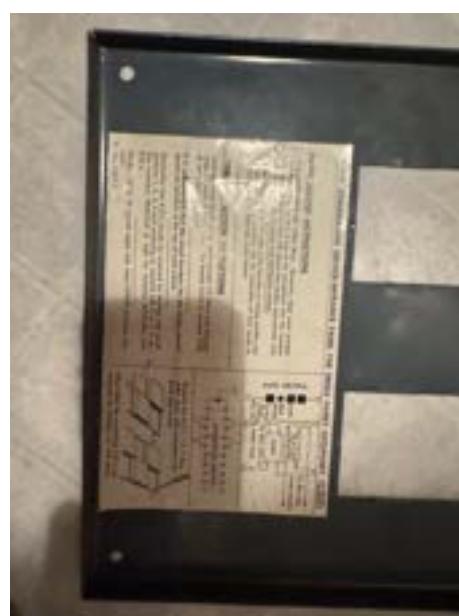
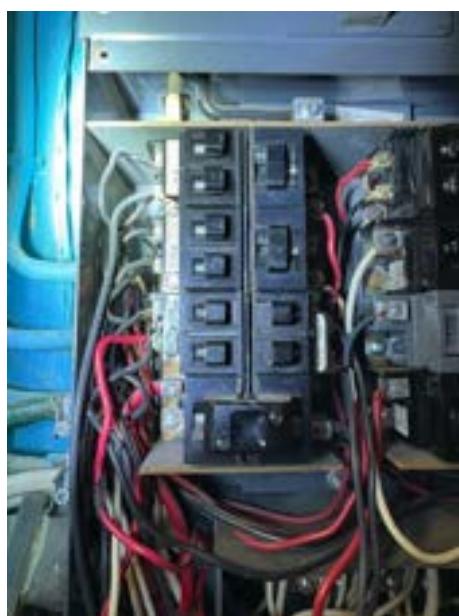
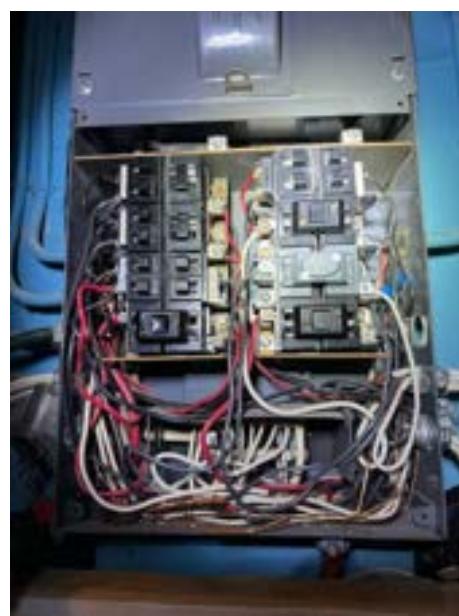
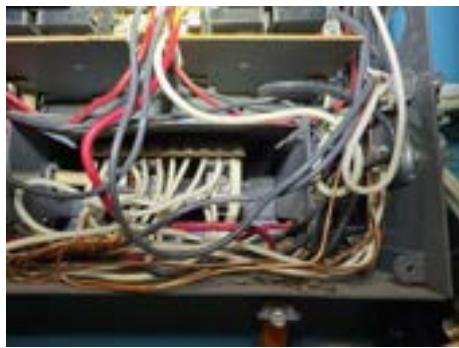
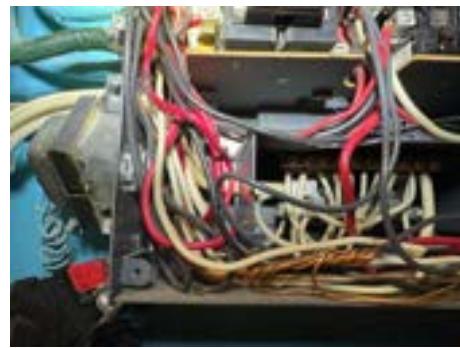
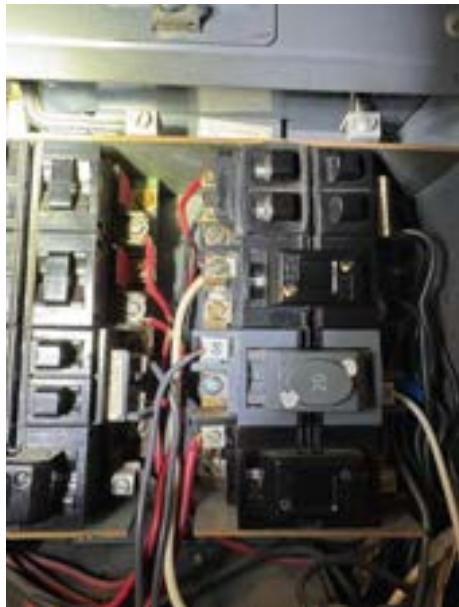
ELECTRICAL

- Panel interior is moderately dusty with minor debris observed at the bottom
- No corrosion or active moisture infiltration visible
- Wiring appears aged but serviceable; routing is tight but largely contained

- One neutral conductor appears to be double-tapped (two neutrals under one terminal screw), which is not compliant with most modern panel standards
 - Slight discoloration noted on a few terminal screws; no evidence of overheating or scorch marks at time of inspection
 - Labeling is handwritten and partially faded; circuit identification is incomplete in areas, which may hinder emergency or service work

Panel shows no immediate hazards but contains legacy components and minor code concerns. Recommend evaluation by a licensed electrician to confirm code compliance (particularly with double-tapped neutrals) and consider upgrading labeling for clarity.

Routine inspection and maintenance by a qualified electrician is advised to ensure continued safe operation. Pushmatic panels are considered outdated; future panel replacement should be discussed during major electrical upgrades.

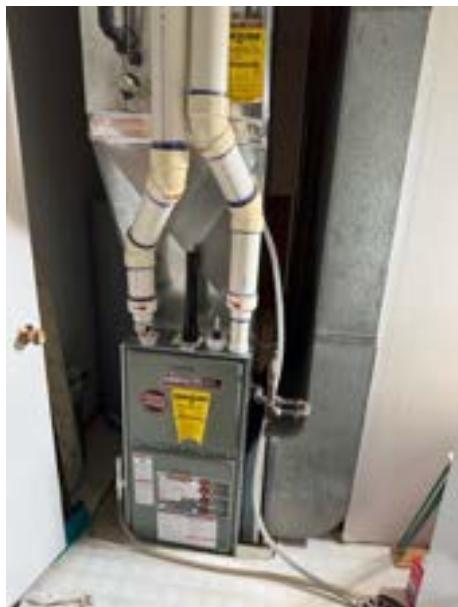
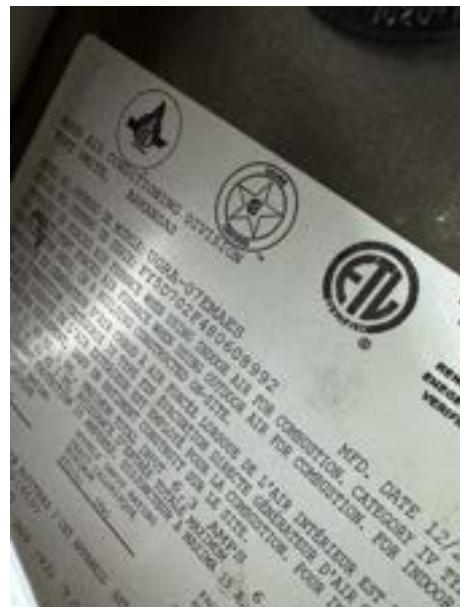
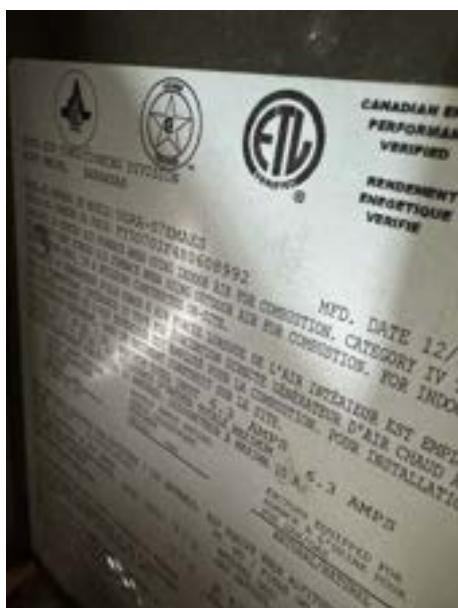
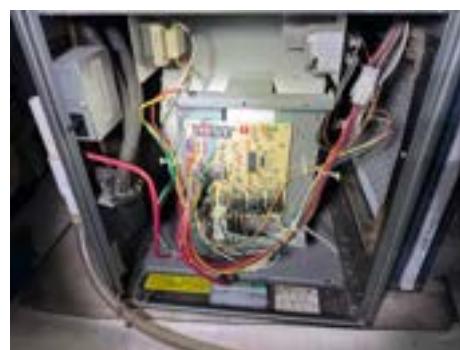
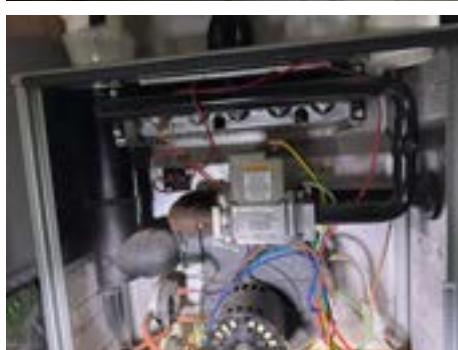
HEATING & COOLING

- No corrosion or active leaks observed on the furnace body or internal components
 - Combustion area and blower compartment are free of excessive dust or debris
 - All visible wiring and circuit board components appear intact with no signs of overheating or damage

Routine servicing, including annual inspection by a qualified HVAC professional and regular air filter replacement, is recommended to ensure safe operation and maintain system efficiency.
