A Unique Task

BUILDING ADDRESS: 123 Anywhere Ave

INSPECTION DESCRIPTION: Home Inspection

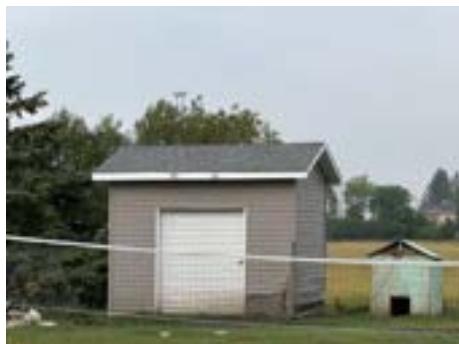
SHED / OUTBUILDINGS Fair

Needs maintenance and repairs.

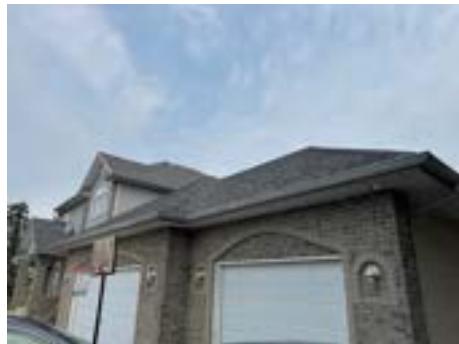
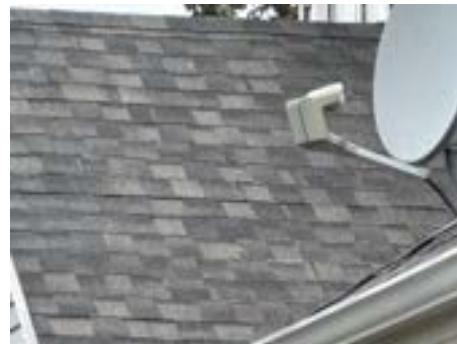
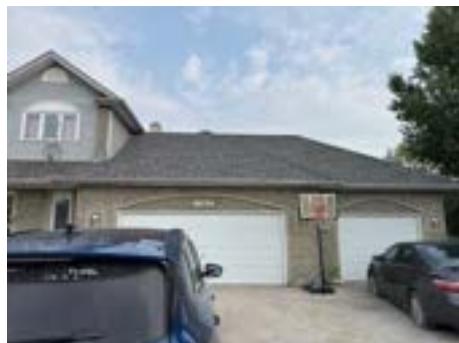
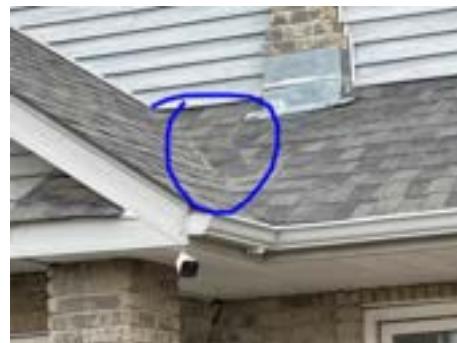
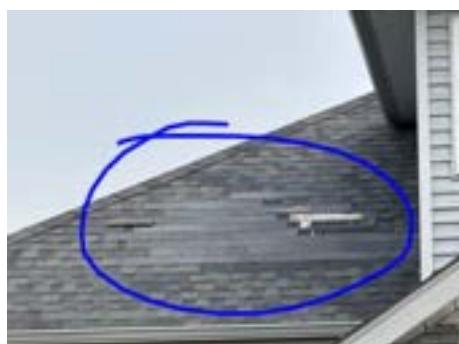
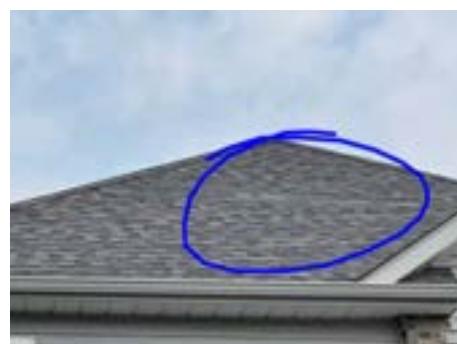
ROOF

39 inch two-tone gray brown, architectural style fibreglass shingles appeared to be in reasonable repair although there is exposed Roof checking that does require detention repair. Some lines are out of place as well. Demand attention. No signs of visible impact no signs of recent repair but these roof does need some attention. Recommend repair by a homeowner or handyman. Needs maintenance and repairs.

Please note that on the south and west facing directions and elevations of this roof covering there is a necessity to have these areas repaired as there is exposed roof decking no signs of underlayment. There is about four spots to be considered that need a meeting attention. This area has been open for considerable amount of time And may have water permeated into the interior which may need to be addressed as well. Continue to monitor, if condition deteriorates contact a qualified contractor. Needs maintenance and repairs. Recommend repair by a homeowner or handyman.

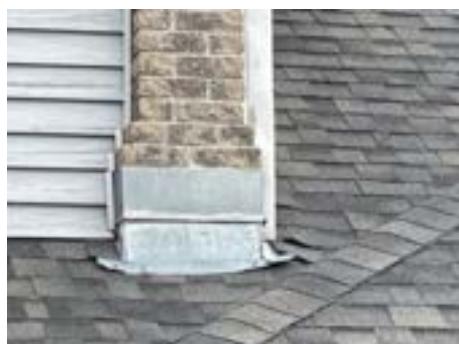
Needs maintenance and repairs.

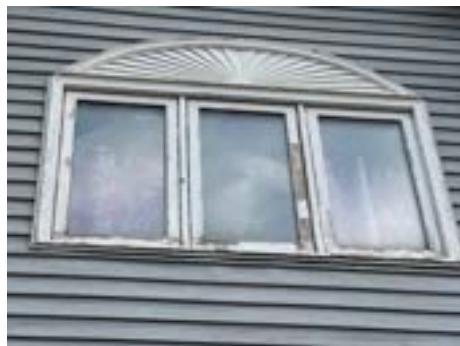
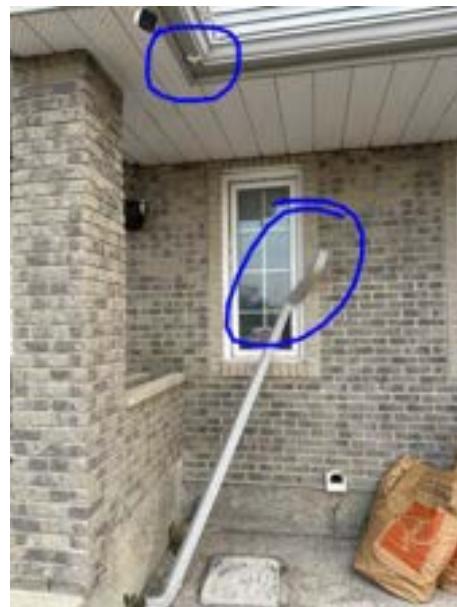
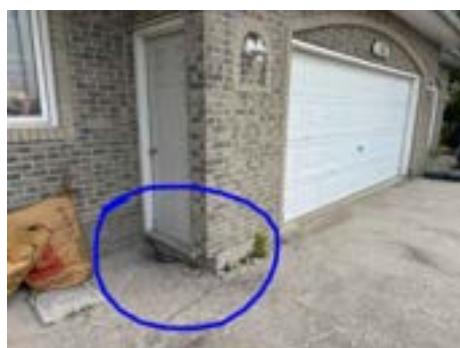
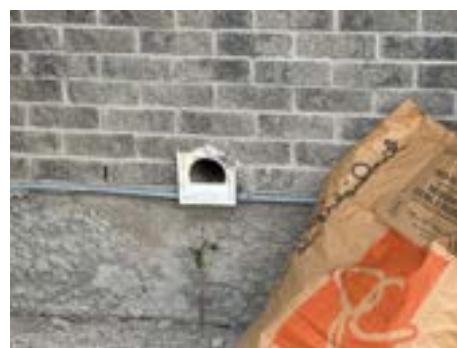
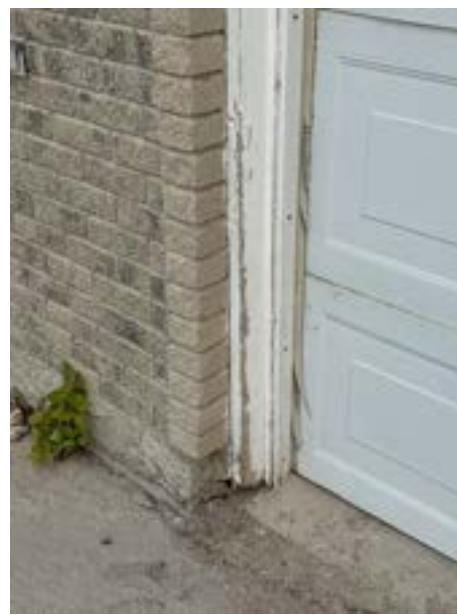
Exterior façade has a combination of vinyl siding as well as a brick. Appears to be in reasonable repair, although there are minor deficiencies that need to be corrected to some of the downpipe some of the vents. Needs maintenance and repairs. Prime, fill, sand, paint/stain to match. Please note that the extension pipe should lead as far as far with the property as possible to prevent any erosion or settlement back into the property of standing water. Stucco in areas as well as window trim I do require maintenance or repair. Screens in windows Needs maintenance and repairs.

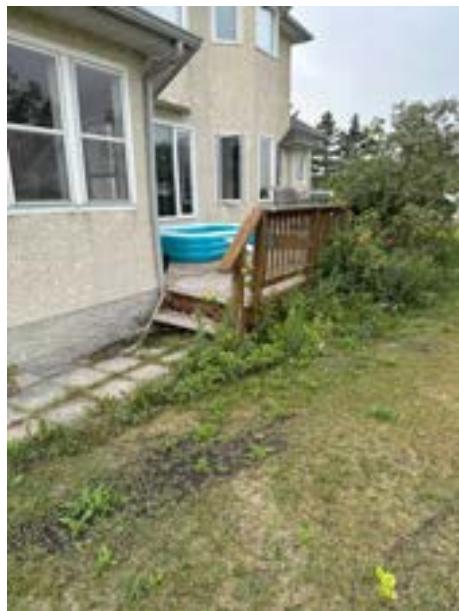
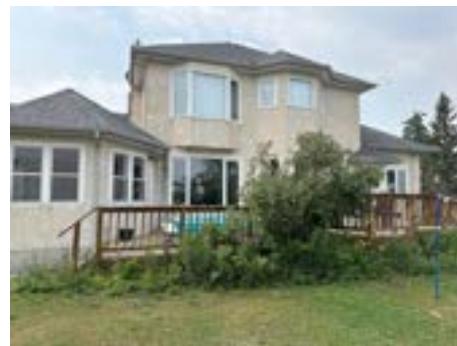
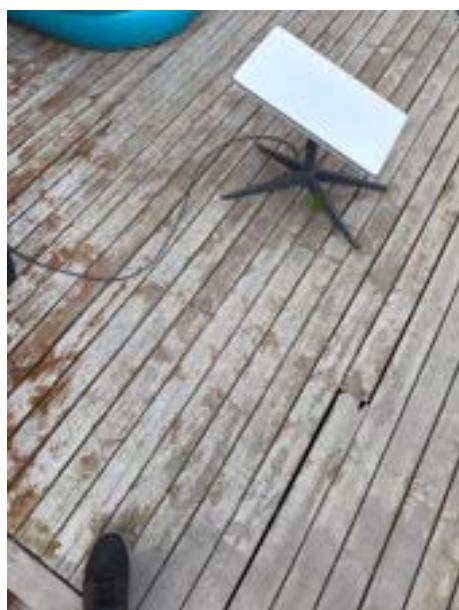
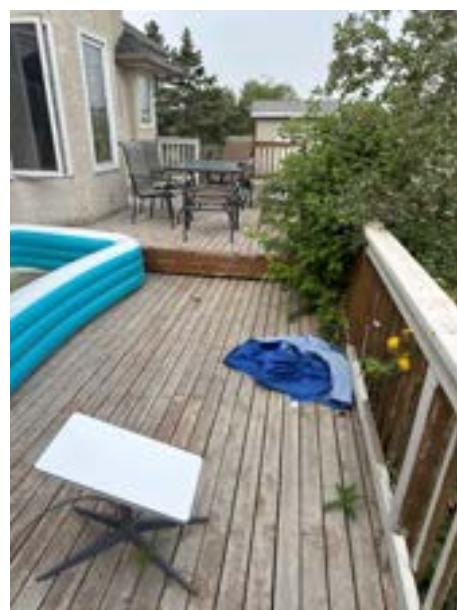
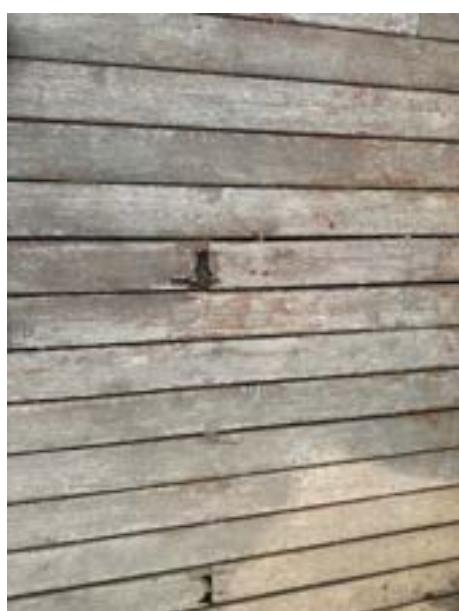
Needs maintenance and repairs. Note not level. Should be resecured

Deck and Steps: Re-secure decking and replace deteriorated components for safe use.

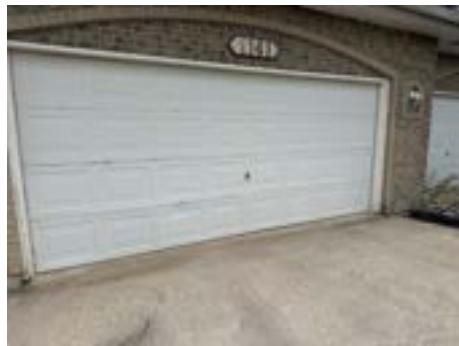
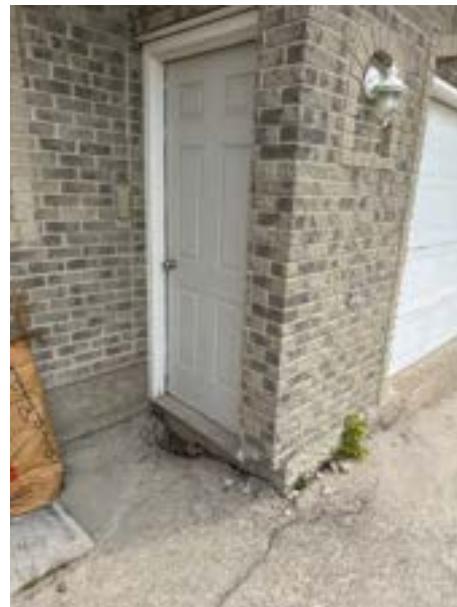
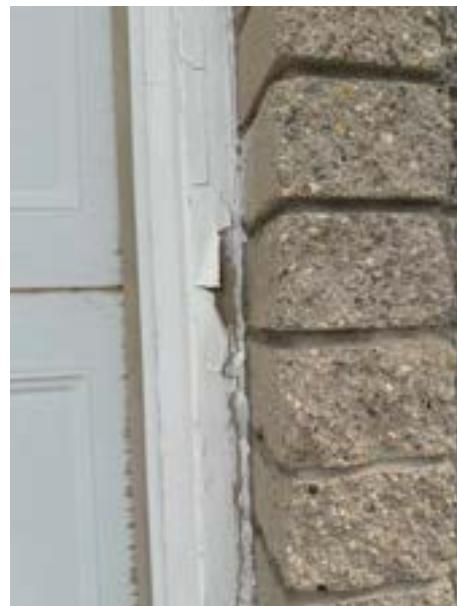
Exterior garage door, showing signs of deterioration and rust and corrosion, as well as signs of denting and movement. This however, does not affect its operation but may need to be readjusted.

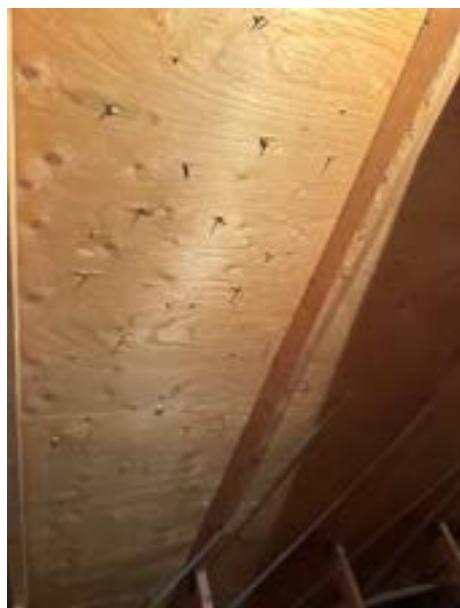
Note to the exterior roof recovery requires attention repair as there was at one time leakage into the attic area where the roof shingles are missing. Otherwise the sheathing is in good repair. Good condition.

Inspect attic for past water damage.

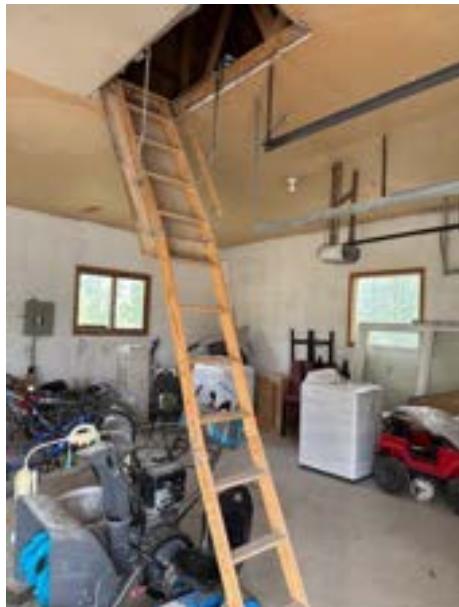
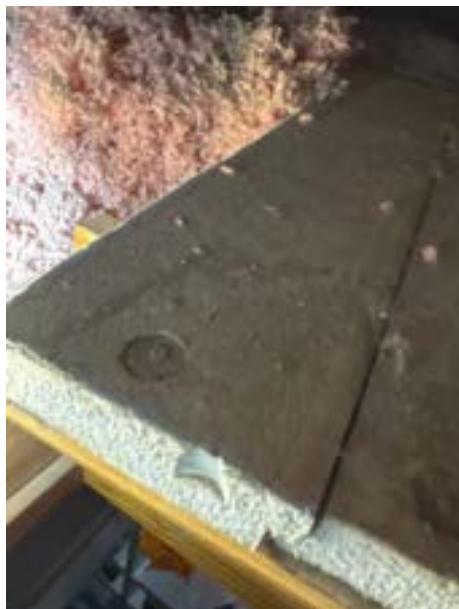
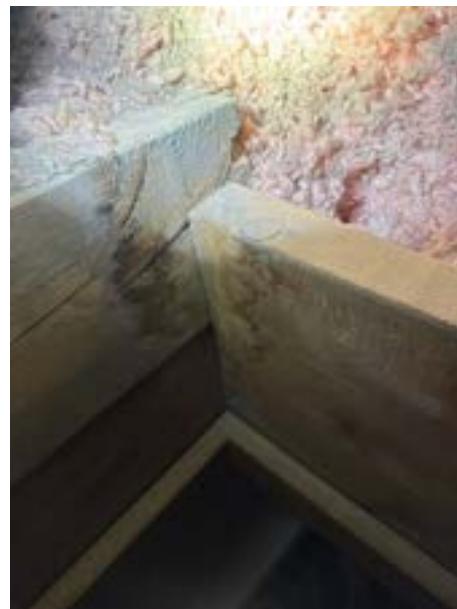
Well insulated recommend weatherstripping

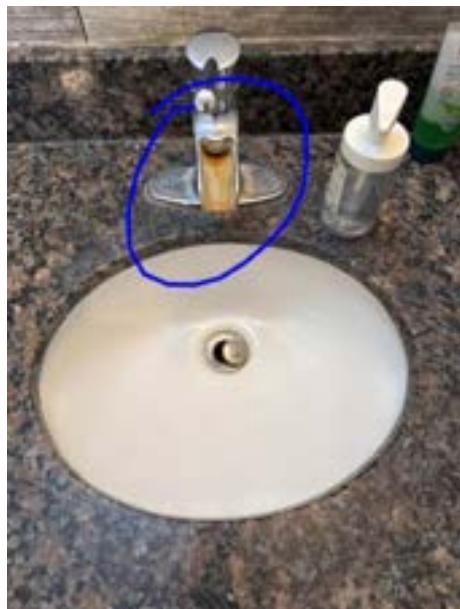
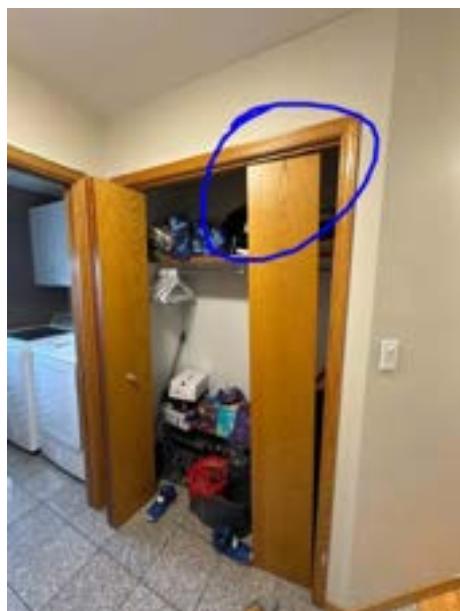
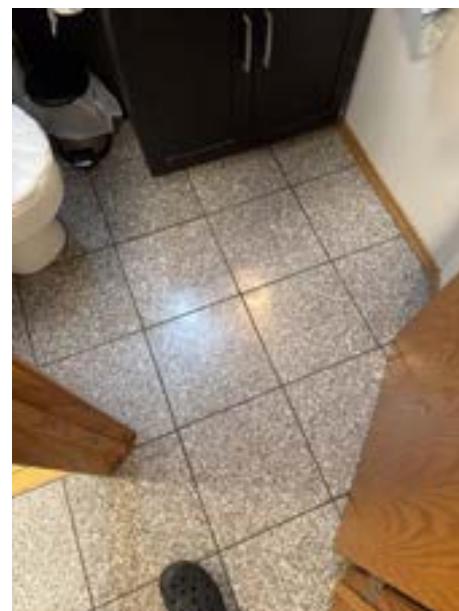
All test ok gfi but staining on outlet

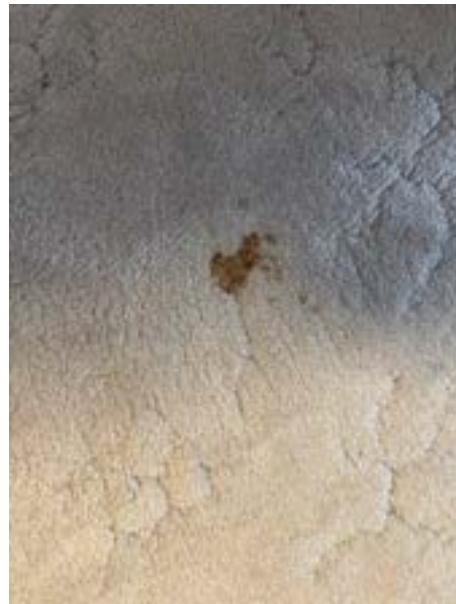
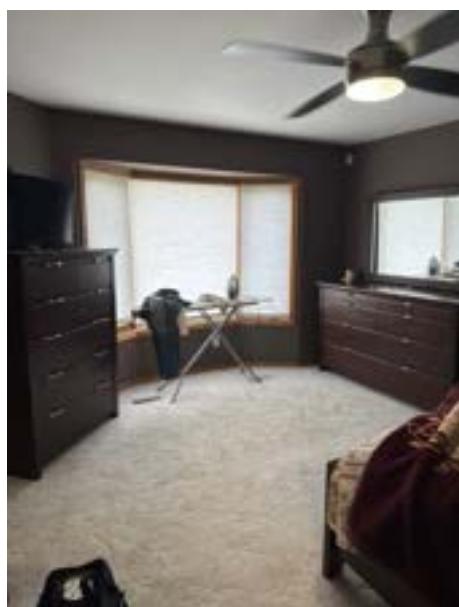
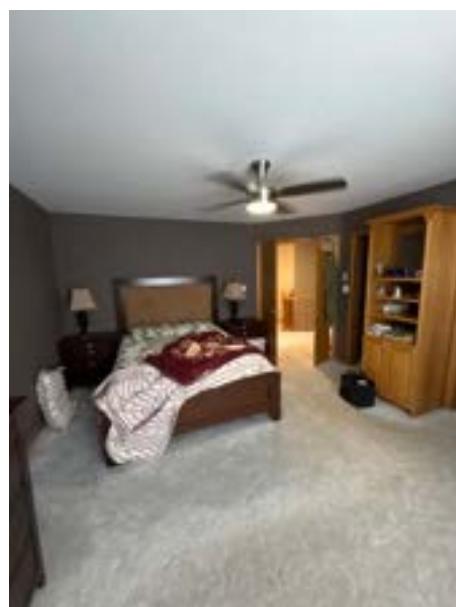
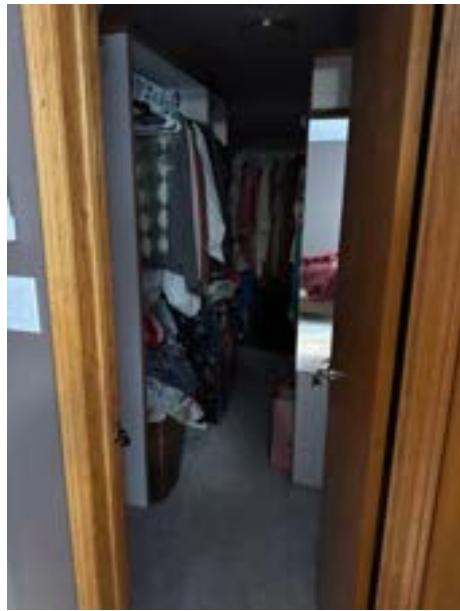
Primary

Cleaning needed as well visible stains

Needs maintenance and repairs. Prime, fill, sand, paint/stain to match

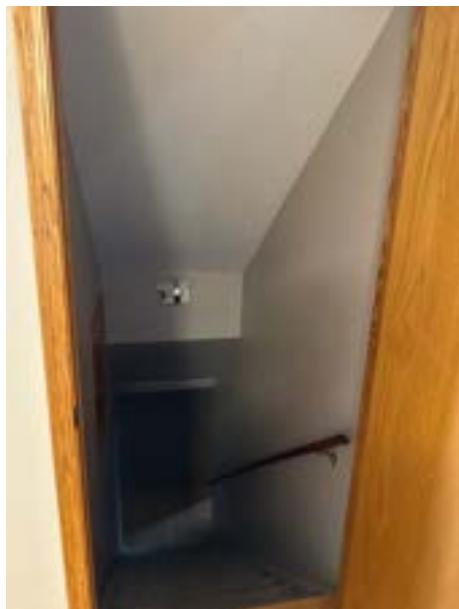
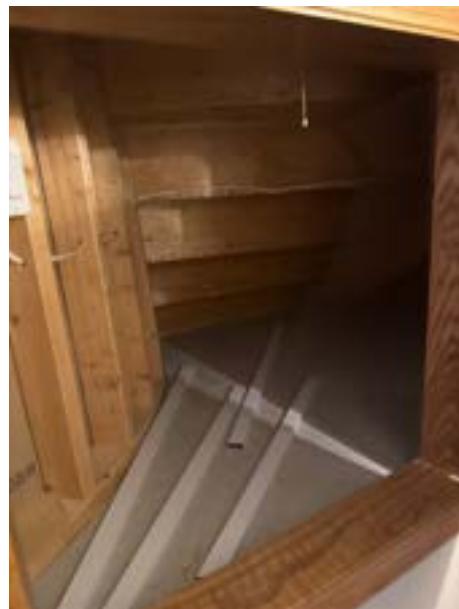
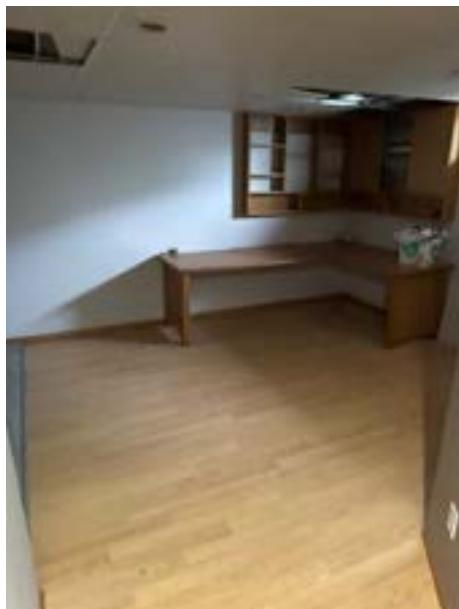
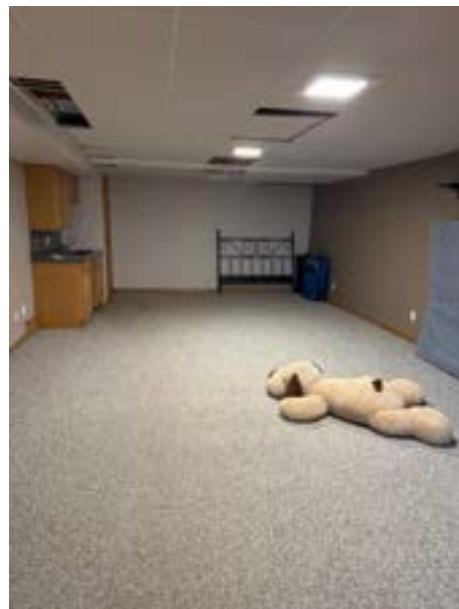
To basement

Needs maintenance and repairs. Recommend repair by a homeowner or handyman.

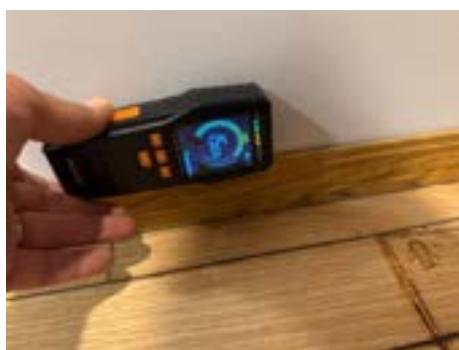
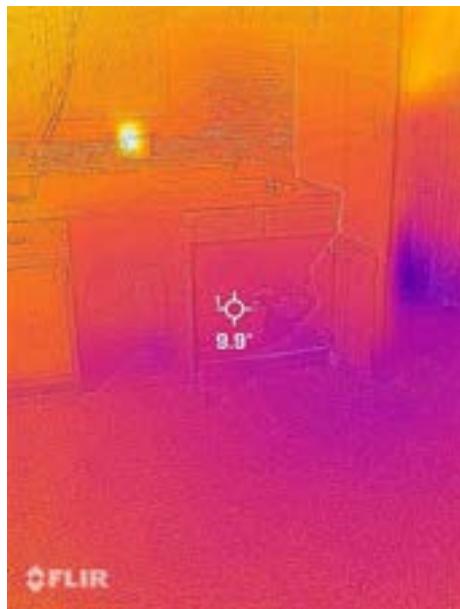
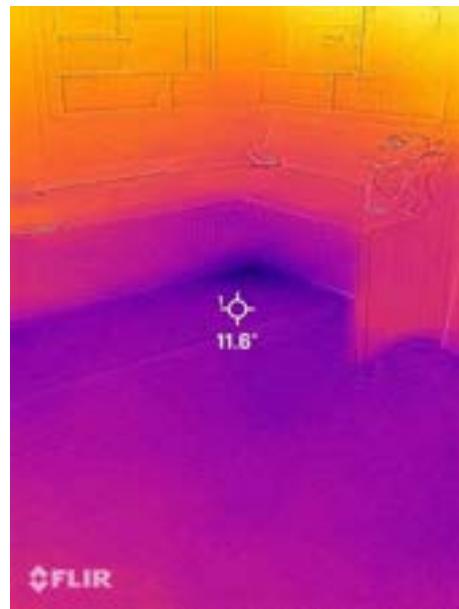
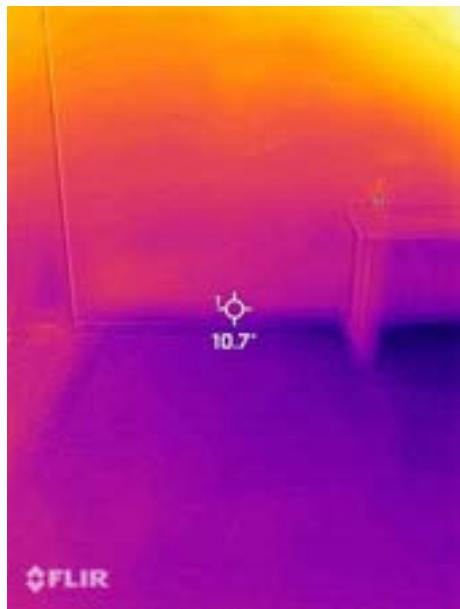
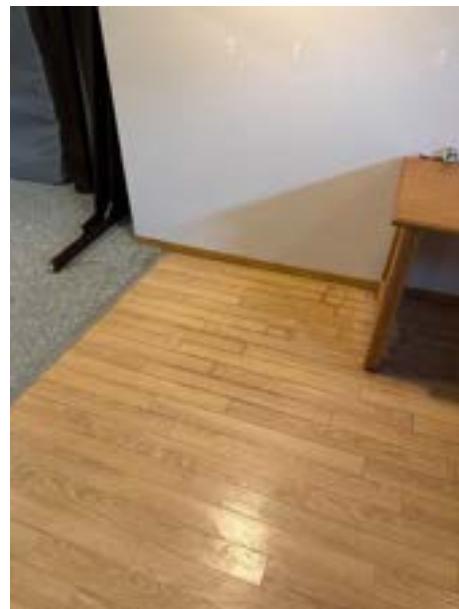
Basement floor meters wet in corners signs of seepage and continuous leakage from poor grading

Due to standing water drywall is wet and requires mitigation.

Recommend further evaluation by a qualified contractor. Basement has seepage

Recommend repair / replacement by a homeowner or handyman. Needs maintenance and repairs. Prime, fill, sand, paint/stain to match.

Basement Moisture: Apply interior sealant, monitor sump pump function, and consider foundation waterproofing if seepage persists.

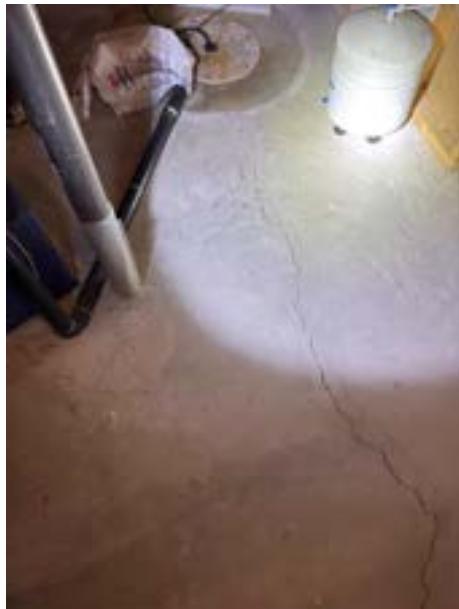
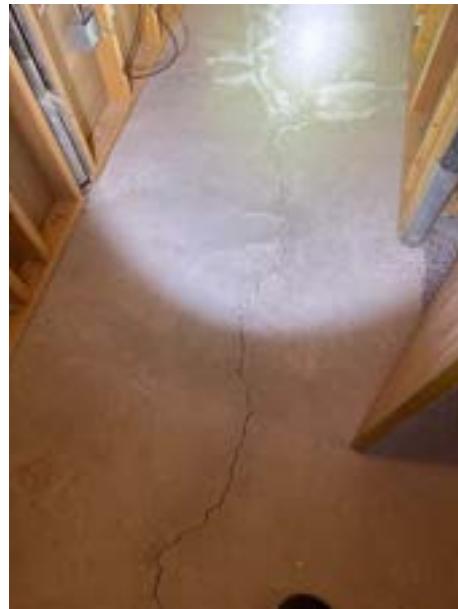
Minor movement cracks normal no signs of heaving

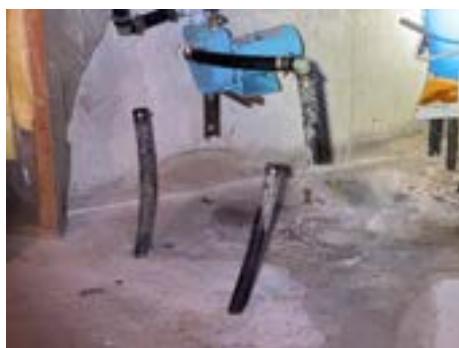
Minor seepage due to improper grading on exterior

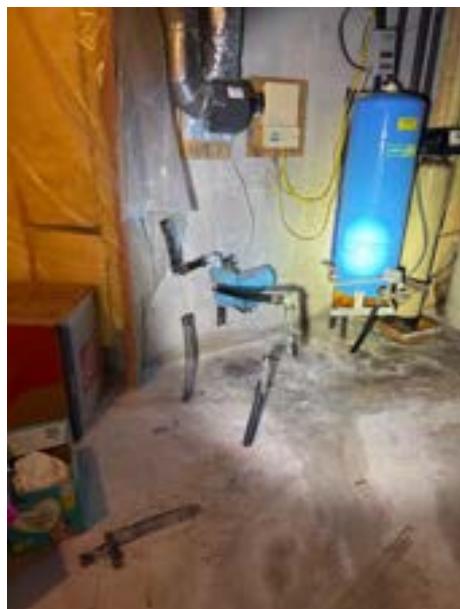
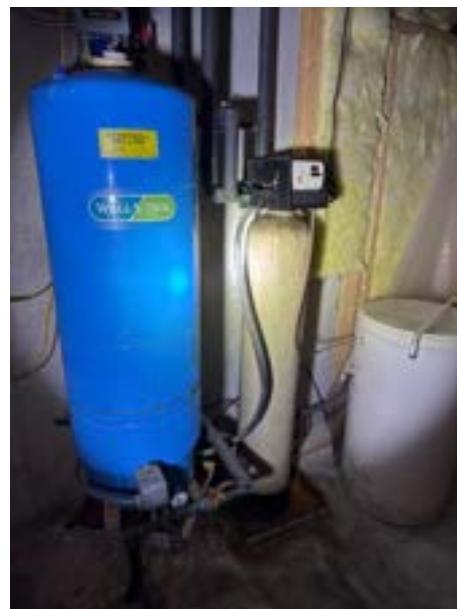
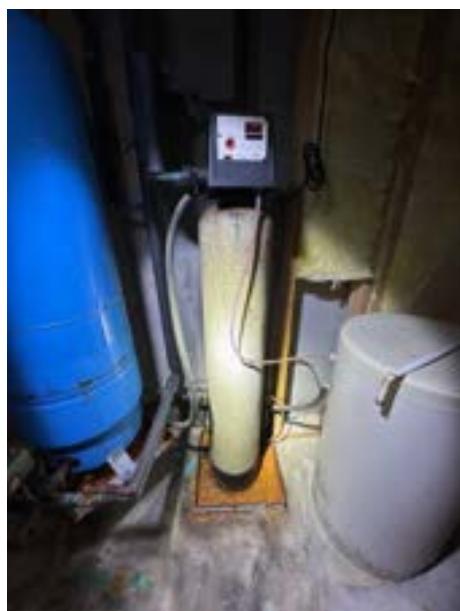
MAIN SHUTOFF VALVE Fair

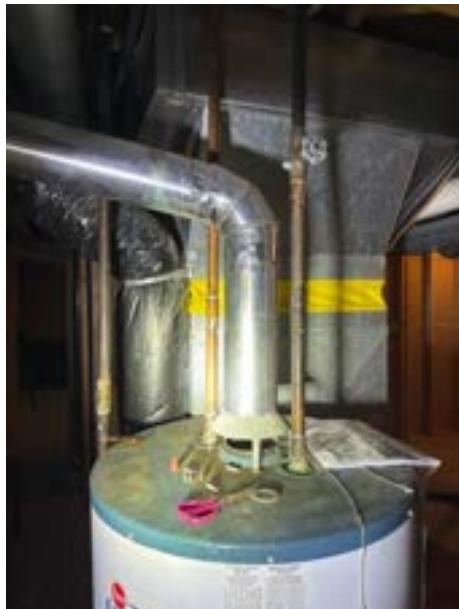
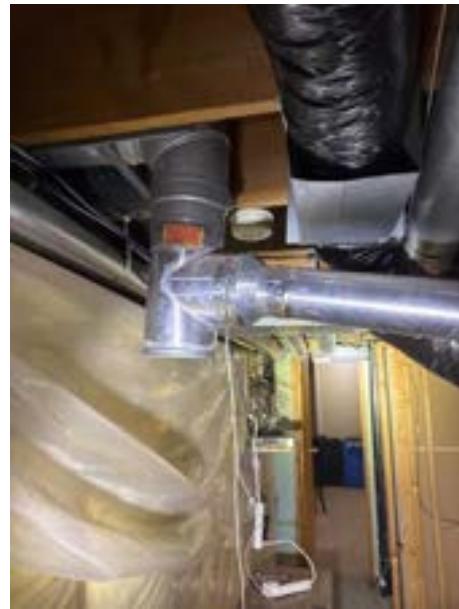
Plumbing system primarily made up a copper piping

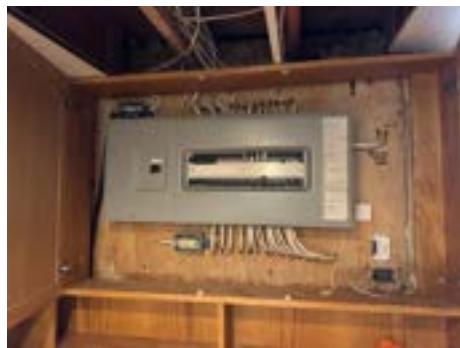
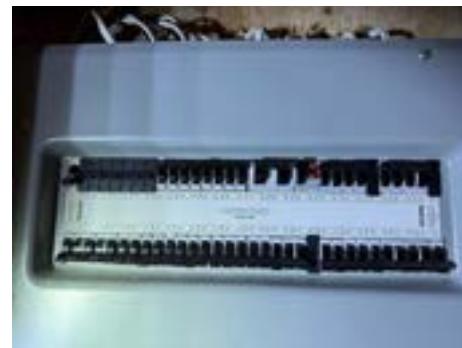
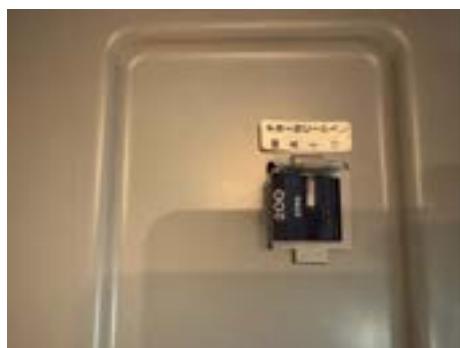
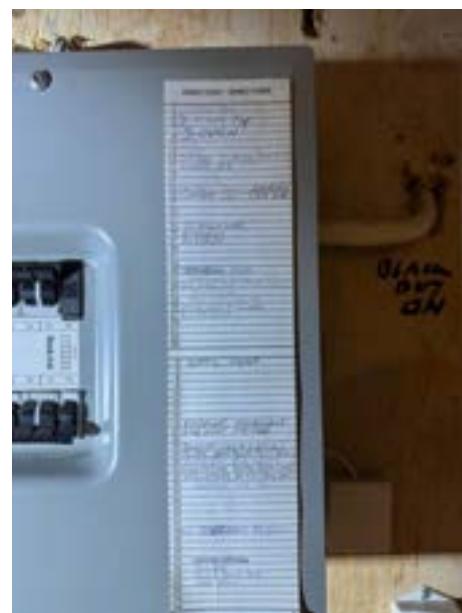
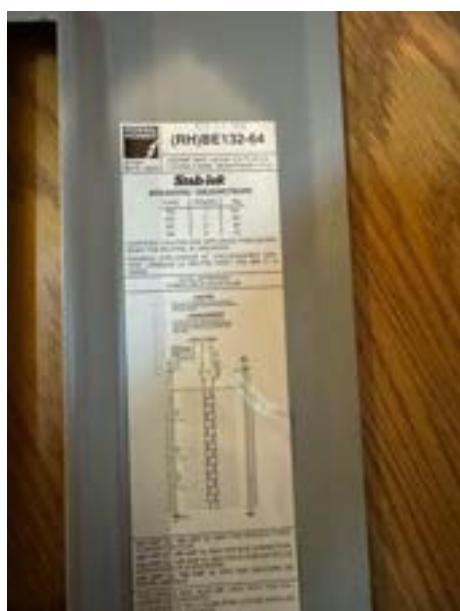
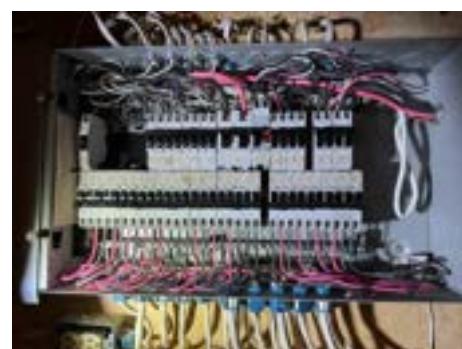
- Interior is generally clean with no visible signs of corrosion or rust
- No apparent water intrusion or burn marks
- Breakers and wires appear intact

- Multiple conductors (double-taps) visible under single terminal lugs—this is not approved on most breakers and presents a fire hazard
 - Overcrowded wiring and excessive bending radius may impede heat dissipation and future servicing
 - Some neutral and ground wires share the same terminal, which may violate current code if panel is not configured as main bonding location
 - Wiring entering the panel lacks proper strain relief in areas
 - Use of Federal Pioneer Stab-lok breakers, which are known for historical safety concerns including failure to trip under overcurrent conditions

Due to observed double-taps, crowded wiring, and presence of Stab-lok breakers with known reliability concerns, recommend evaluation by a licensed electrician for correction and potential panel replacement.

Routine inspection and maintenance by a qualified electrician is advised to ensure continued safe operation.

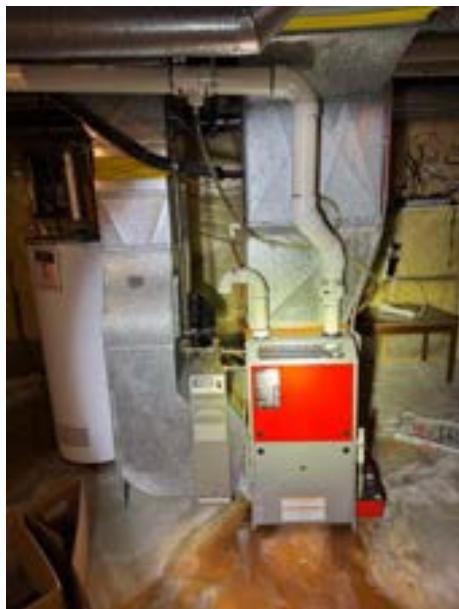
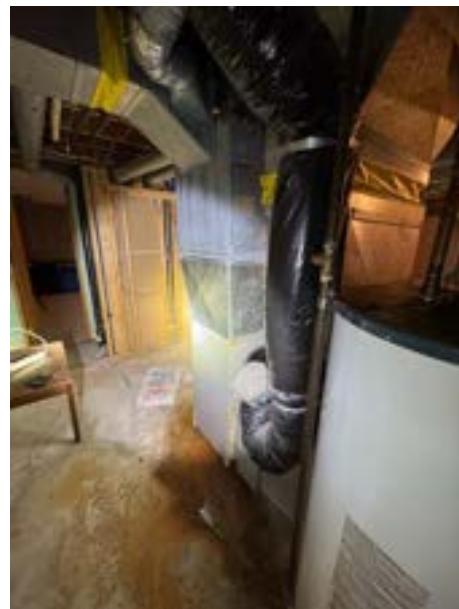
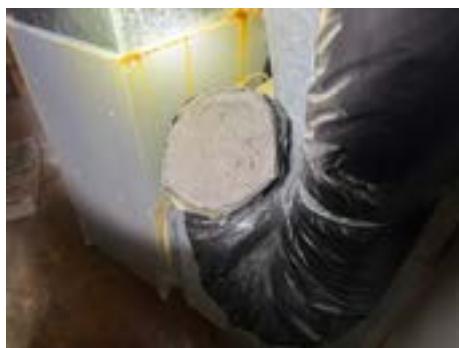
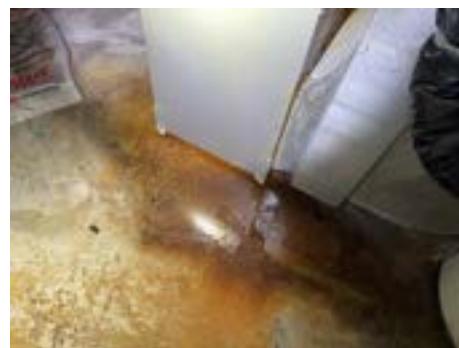
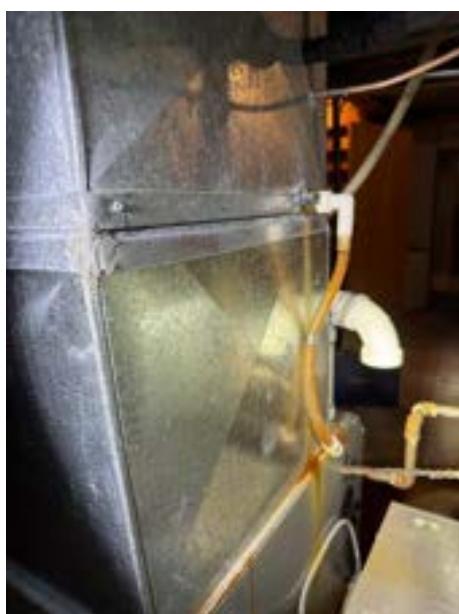
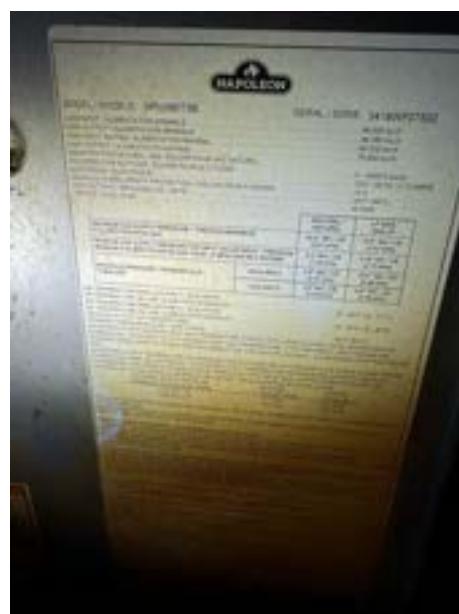
The furnace shows advanced rust and corrosion along the lower panel and internal compartment, indicating prolonged condensate accumulation. Drainage piping displays visible mineral buildup and staining, with multiple signs of leakage at joints and terminations. The condensate tubing appears crimped and obstructed, which may impair proper drainage. Electrical wiring and internal control board components are exposed to a visibly rusted and damp environment. The air intake screen is heavily dust-laden and requires immediate cleaning or replacement.

Routine annual servicing by a licensed HVAC technician is strongly advised. This includes condensate line flushing, filter replacement, burner inspection, and verification of blower operation. Addressing these maintenance needs promptly will help extend the furnace's operational life and ensure safe, efficient performance.

Furnace: Clean and repair condensate lines. Replace corroded parts and perform full HVAC servicing.

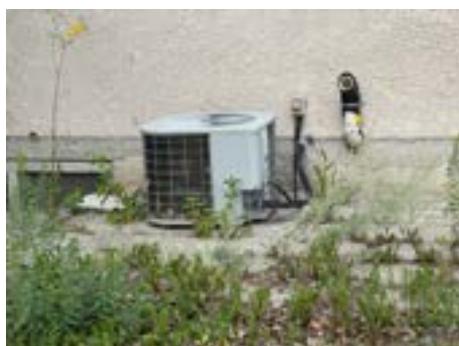
COOLING SYSTEM Fair

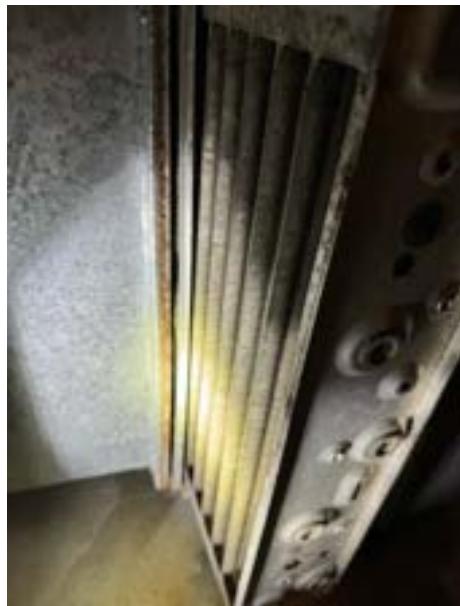
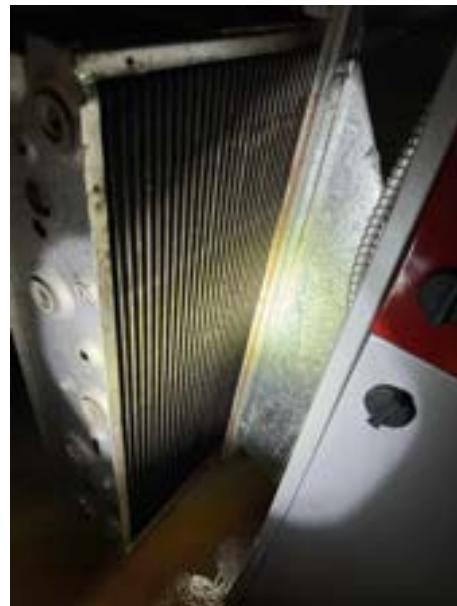
Cleaning needed

Clean electrostatic furnace filters monthly with water and mild detergent; allow to dry fully before reinstalling to maintain airflow and efficiency.
