A Unique Task

General Information

BUILDING ADDRESS: 987 Walkthrough Drive

INSPECTION DESCRIPTION: Walk through inspection

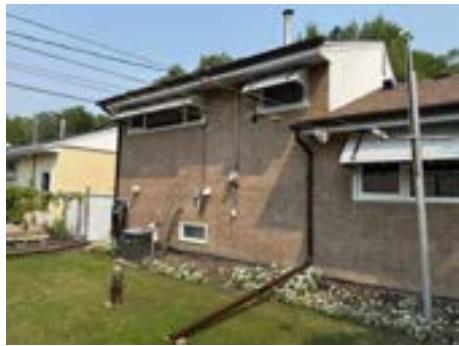
LANDSCAPE GRADING Poor

Grading should be increased to allow water to flow away from foundation.

Proper grading around the home is essential to protect the foundation and maintain structural integrity. The ground should slope away from the foundation at a minimum rate of 6 inches over the first 10 feet (a 5% grade) to ensure that surface water drains away rather than pooling near the structure.

Inadequate grading can lead to serious moisture-related issues, including:

- * Water intrusion into basements or crawlspaces
- * Foundation cracking or shifting
- * Mold growth and wood rot
- * Elevated indoor humidity and poor air quality
- * Deterioration of exterior finishes and landscaping

- * Monitor for soil settlement, erosion near downspouts, and negative slope development over time
- * Ensure landscaping changes or new construction do not compromise the slope
- * Downspouts should discharge a minimum of 6 feet away from the foundation to support proper drainage

Conclusion: Proper grading is a critical defense against damage, moisture intrusion, and costly repairs. It is recommended that homeowners periodically inspect grading conditions and make adjustments as needed to maintain positive drainage away from the home.

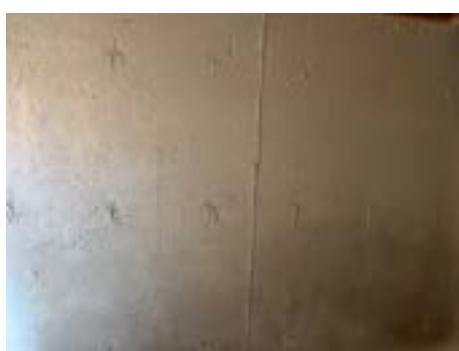
SLAB N/A

No heaving just uneven pour of concrete. Due to lack of ventilation and poor workmanship concrete and paint peeling.

Poured concrete foundation. No active heaving observed; however, surface concrete shows peeling due to poor ventilation. Grading is poor and requires improvement to prevent moisture intrusion.
